STM8AF622x/4x/66/68 STM8AF612x/4x/66/68 errata sheet

Device limitations for STM8AFxxxx automotive MCUs
featuring up to 32 Kbytes of Flash program memory

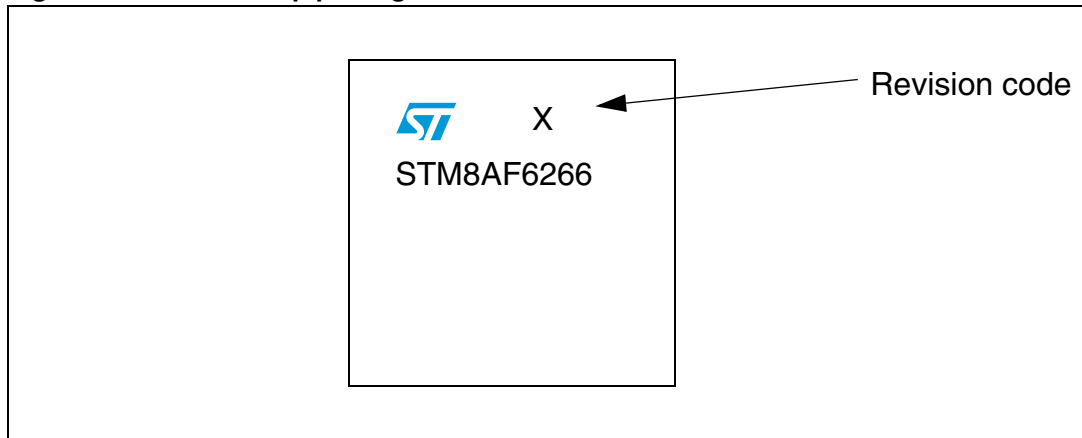
Figure 1. LQFP32 top package view

Figure 1 shows the marking for the LQFP32 package.
