# STM32L151xx and STM32L152xx Errata sheet

## STM32L151xx and STM32L152xx ultralow power limitations

This errata sheet applies to the revision W of the STMicroelectronics STM32L151xx and STM32L152xx ultralow power products. This family features an ARM™ 32-bit Cortex®-M3 core, for which an errata notice is also available (see [Section 1](#) for details).

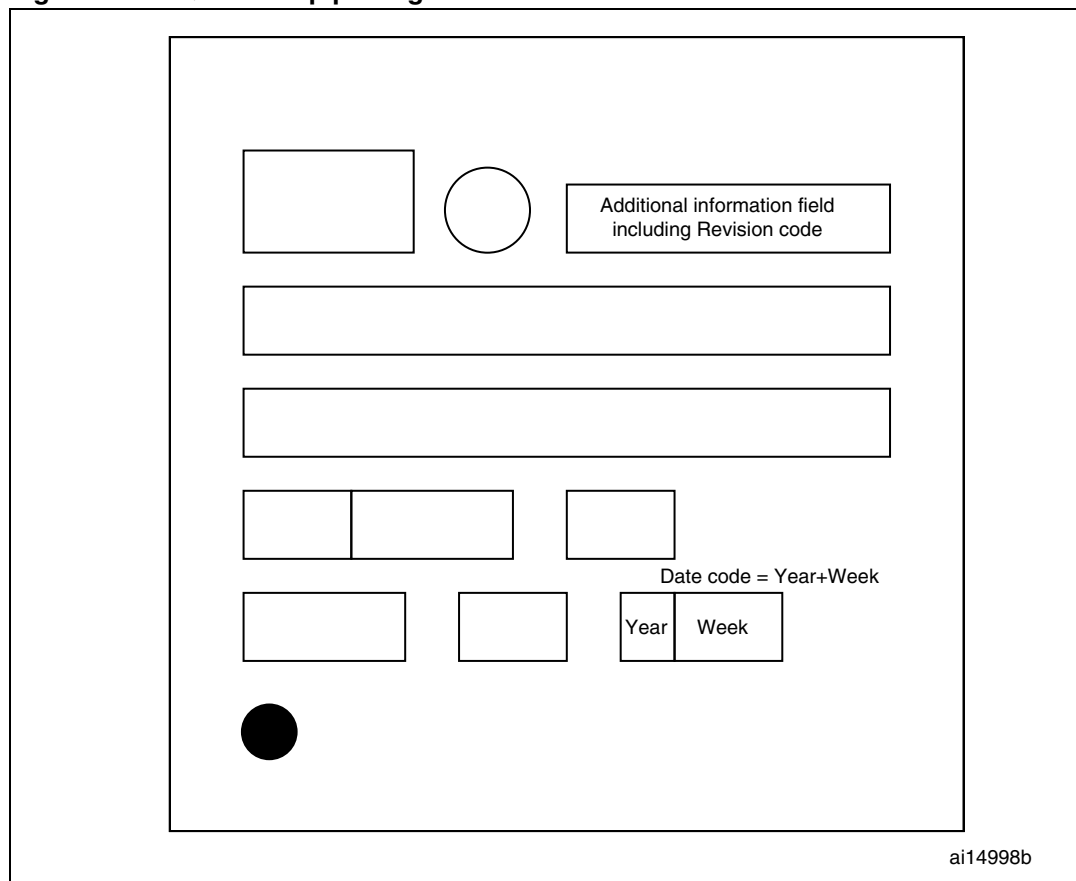
Figure 1. LQFP100 top package view

Figure 1 and Figure 2 show the marking compositions for the LQFP100 and LQFP64 packages, respectively. The only fields shown are the “additional” field, containing the revision code, and the “year” and “week” fields making up the date code.
