STM32W108xx Errata sheet

STM32W108xx device limitations

This errata sheet applies to the STMicroelectronics STM32W108xx microcontroller family.

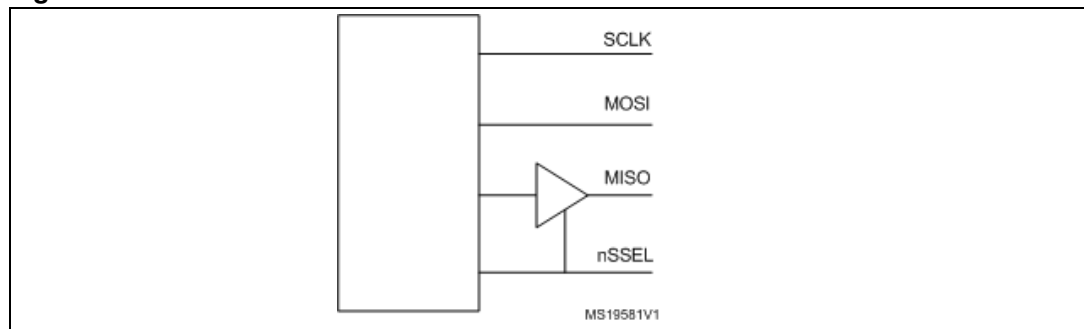
Figure 1. External MISO buffer

There is an issue in the serial controllers of the chip which prevents it from being used on a SPI bus that is shared with other SPI slave peripherals. The MISO (Master-In /Slave-Out) output from the chip does not tri-state when nSSEL (Slave Select) is deasserted.

This causes contention on the shared MISO signal with other peripherals when they are selected via their own nSSEL inputs. The MISO output will continue to be driven either high or low, depending on the state of the last bit that was transmitted prior to nSSEL deasserting.

If the chip is directly connected to a SPI master with no other SPI peripherals on the bus, the bug does not cause any contention or other communications issues.

As shown in [Figure 1](#), an external buffer may be added to the MISO output with its enable connected to nSSEL. This buffer will allow the MISO signal presented to the SPI bus to be tri-stated, and will allow other SPI slave peripherals to share the same bus.
