STM8L15xM8/R8/C8/R6 STM8L162x8 Errata sheet

STM8L15xM8/R8/C8/R6 and STM8L162x8
device limitations

This errata sheet applies to the revision Z of the STMicroelectronics STM8L151M8/R8/C8/R6, STM8L152M8/R8/C8/R6 and STM8L162x8 devices.

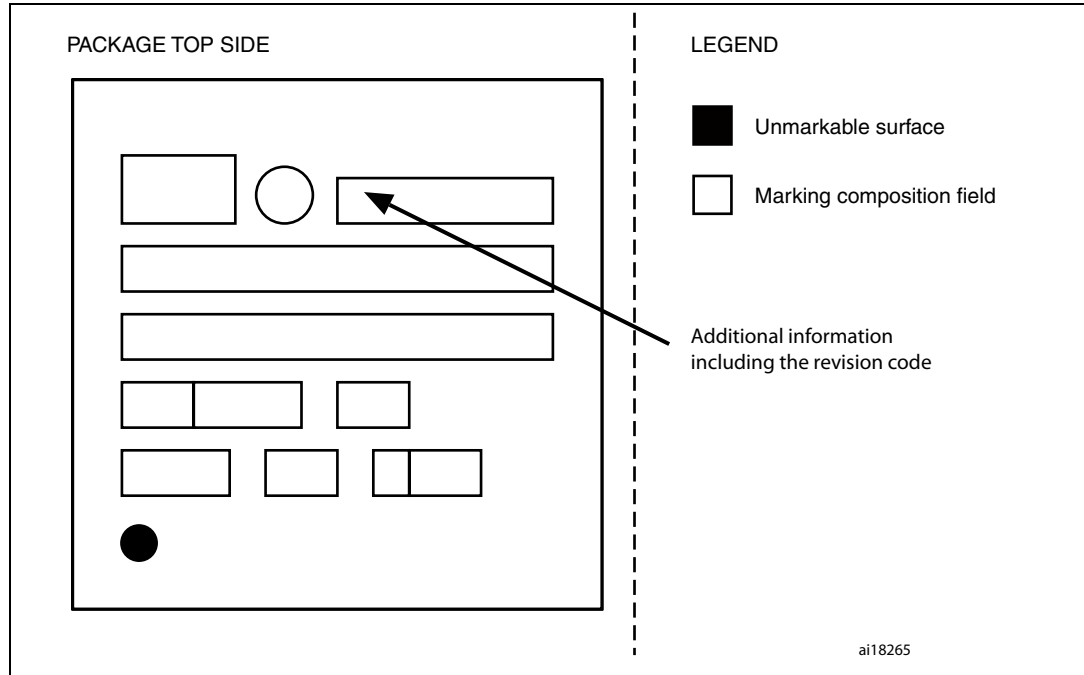
Figure 1. LQFP80 top package view

The following figures show the standard marking compositions for the LQFP80, LQFP64, UFQFPN48, LQFP48 packages, respectively. Only the Additional information field containing the revision code is shown.

- by the revision code marked below the order code on the device package
- by the last three digits of the Internal order code printed on the box label
