STM8L101xx limitations

Silicon identification

This errata sheet applies to revision “B”, “Z” or “Y” of the STMicroelectronics STM8L101xx devices.

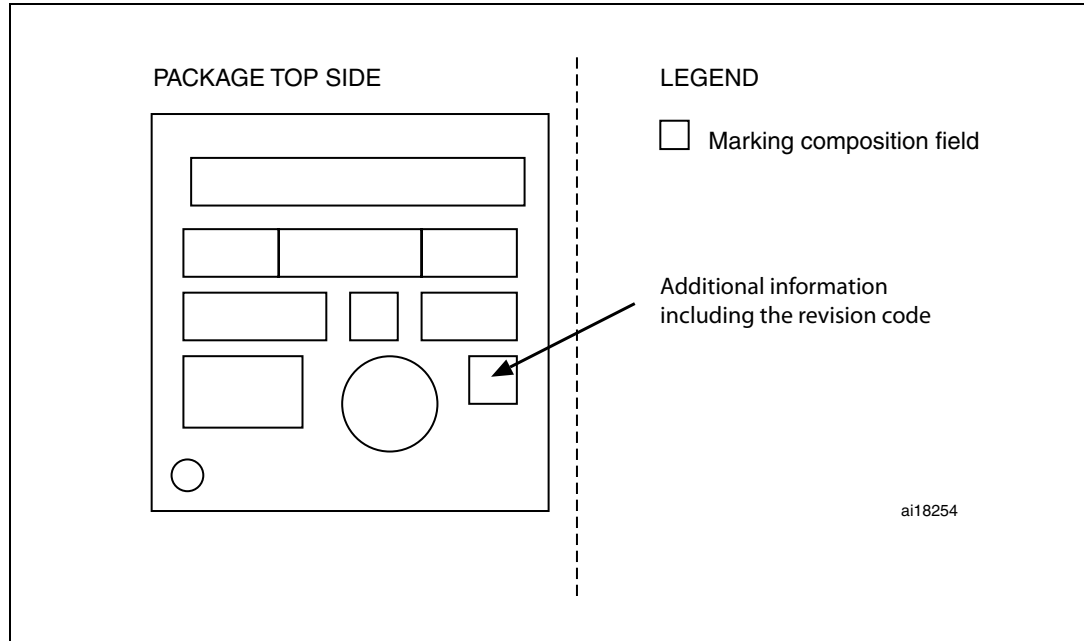
Figure 1. UFQFPN32 top package view

The following figures show the standard marking compositions for the UFQFPN32, LQFP32, UFQFPN28, UFQFPN20 and TTSOP20 packages, respectively. Only the Additional information field containing the revision code is shown.
