STM8L152x4/6 and STM8L151x4/6 Errata sheet

STM8L152x4/6 and STM8L151x4/6 device limitations

This errata sheet applies to revisions B and Z of the STMicroelectronics STM8L152x4/6 and STM8L151x4/6 devices.

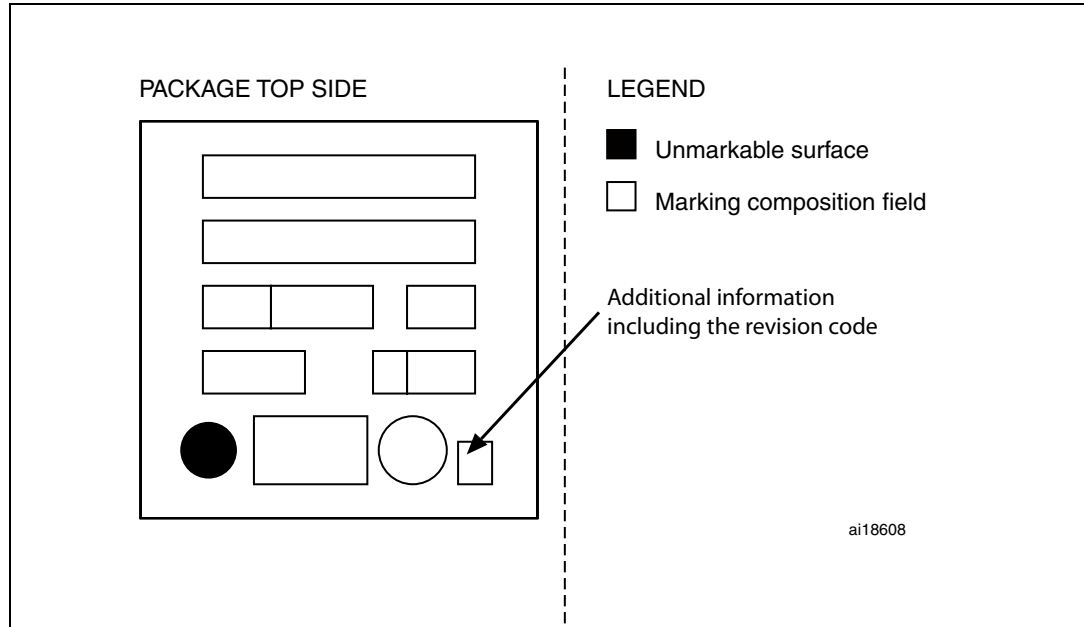
Figure 1. UFQFPN48 top package view

The following figures show the standard marking compositions for the UFQFPN48, LQFP48, LQFP32, UFQFPN32, UFQFPN28 and WLCSP28 packages, respectively. Only the Additional information field containing the revision code is shown.

- by the revision code marked below the order code on the device package
- by the last three digits of the Internal order code printed on the box label
