STM8S performance line device limitations

Silicon identification

This errata sheet applies to revisions X, Y/6 and W/7 of the STMicroelectronics STM8S performance line products.

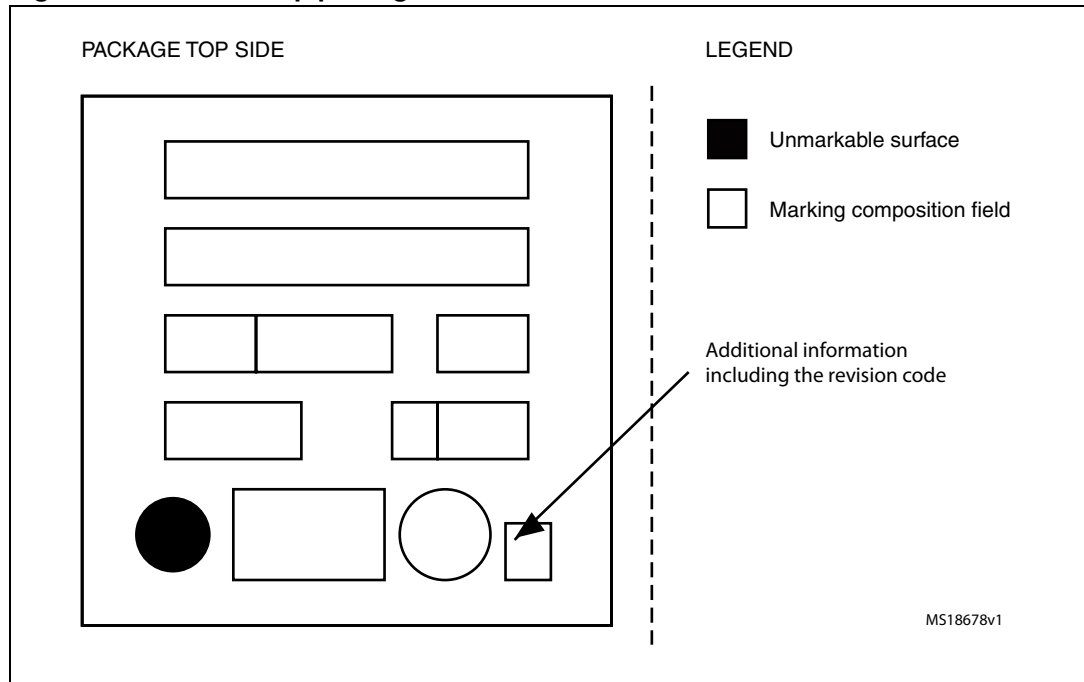
Figure 1. LQFP32 top package view

The following figures show the standard marking compositions for the device packages. Only the Additional information field containing the revision code is shown.

1. Refer to [Appendix A: Revision code on device marking](#) for details on how to identify the revision code on the different packages.
