# STM8S103xx and STM8S903xx Errata sheet

## STM8S103xx and STM8S903xx device limitations

This errata sheet applies to the STMicroelectronics STM8S103xx and STM8S903xx devices.

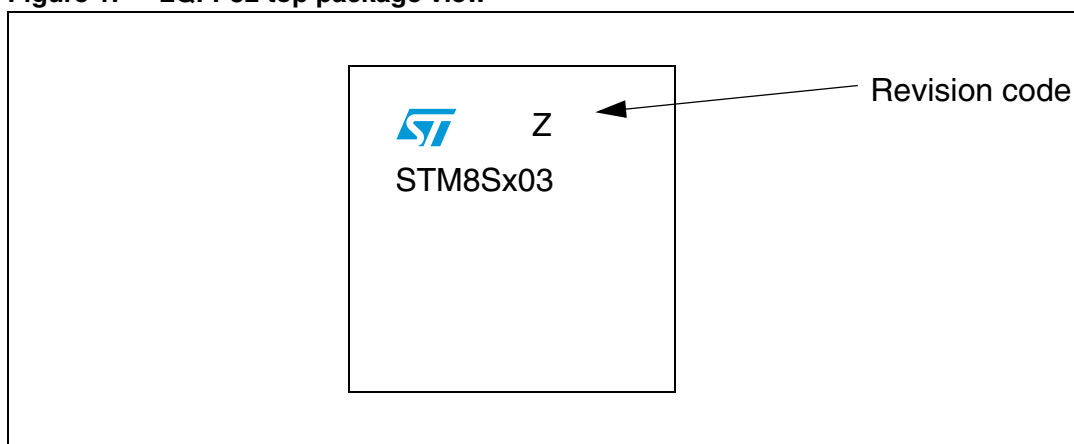
**Figure 1. LQFP32 top package view**

*Figure 1* shows the marking for the LQFP32 package.

1. Refer to [Appendix A: Revision code on device marking](#) for details on how to identify the revision code according to the packages.
